[Docket No. 96-CE-09-AD; Amendment 39-9872; AD 97-01-01]

Airworthiness Directives; The New Piper Aircraft, Inc. PA24, PA28R, PA30, PA32R, PA34, and PA39 Series Airplanes

97-01-01 THE NEW PIPER AIRCRAFT, INC.: Amendment 39-9872; Docket No. 96-CE-09-AD. Supersedes AD 95-20-07, Amendment 39-9386.

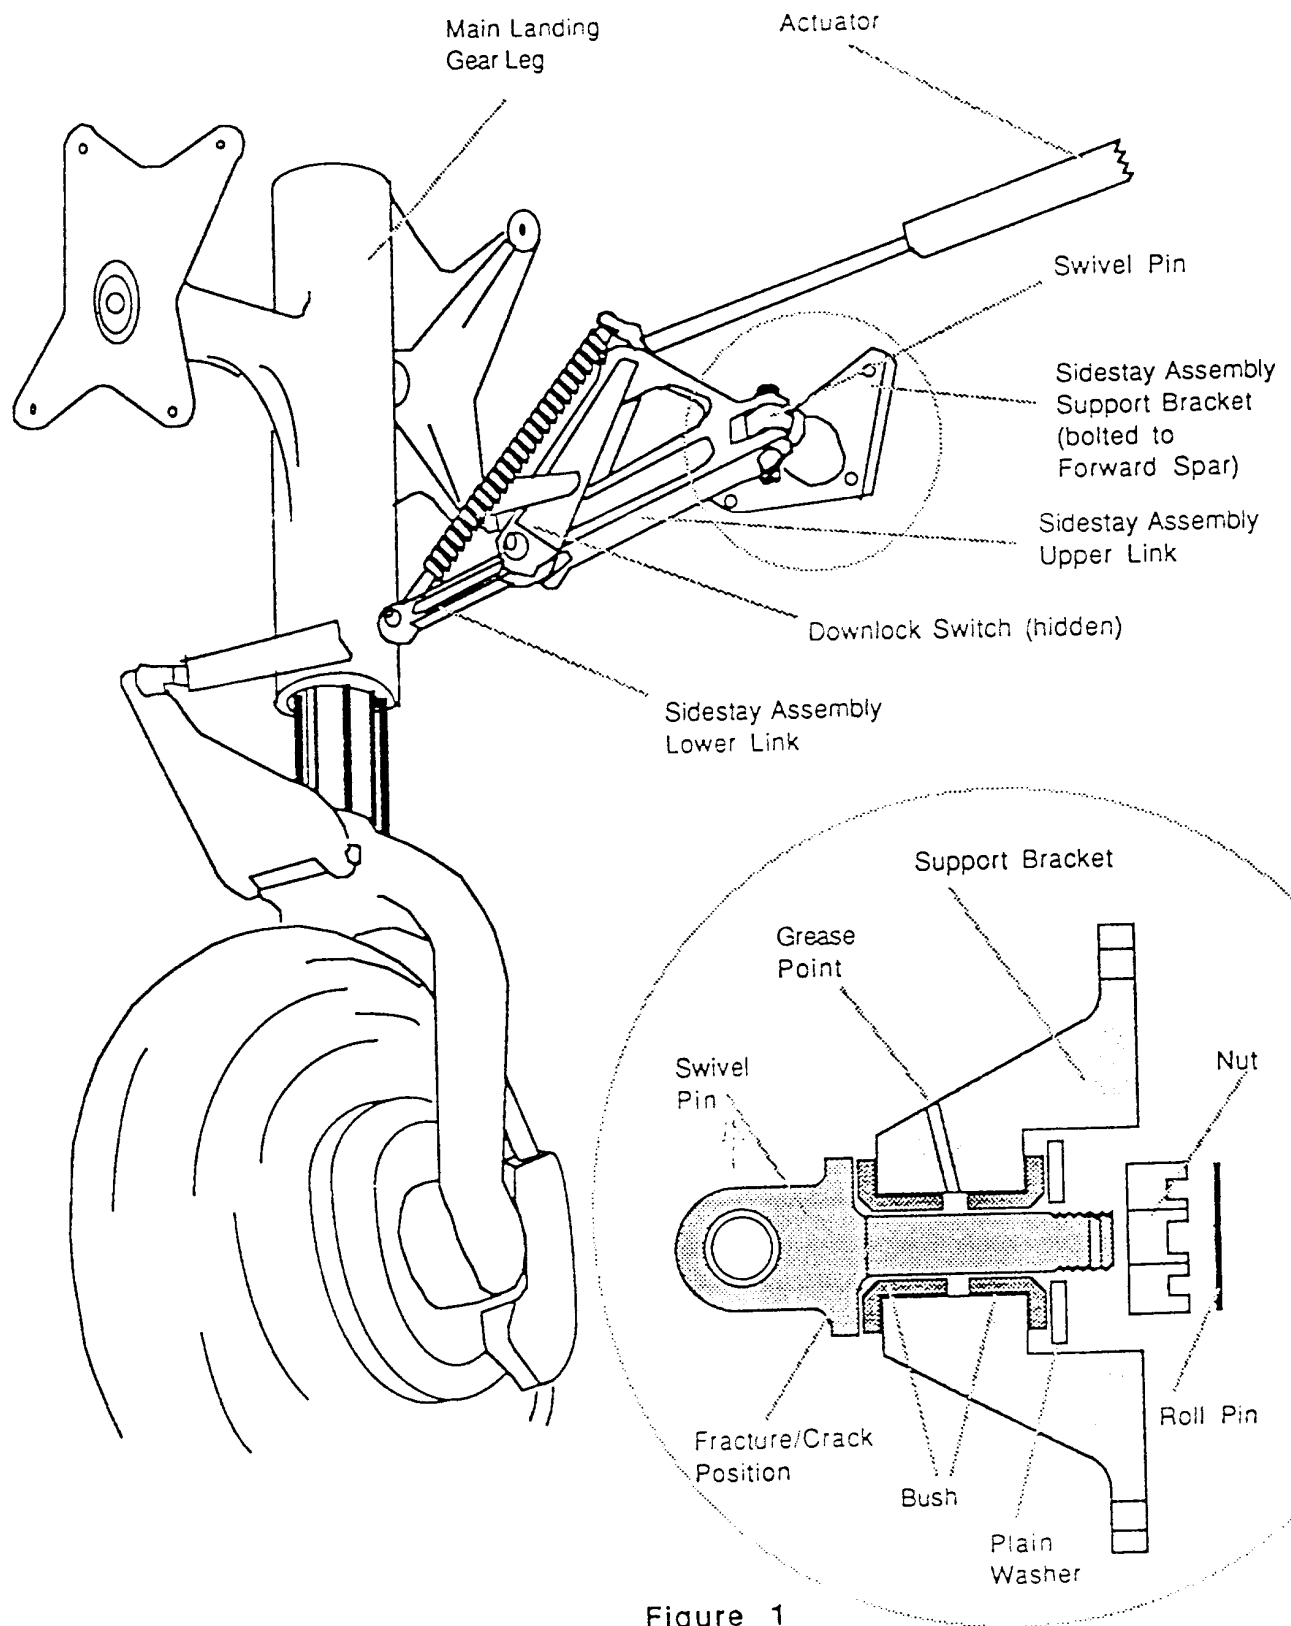
(a) Remove both the left and right main gear sidebrace studs from the airplane in accordance with the instructions contained in the Landing Gear section of the maintenance manual, and inspect each main gear sidebrace stud for cracks, using Type I (fluorescent) liquid penetrant or magnetic particle inspection methods. Figure 1 of this AD depicts the area of the sidebrace stud shank where the sidebrace stud is to be inspected.

(1) For any main gear sidebrace stud found cracked, prior to further flight, replace the cracked stud with an FAA-approved serviceable part (part numbers referenced in the table in paragraph (b) of this AD or FAA-approved equivalent) in accordance with the instructions contained in the Landing Gear section of the applicable maintenance manual, and accomplish one of the following, as applicable:
